UM-3732-98 1998 Oldsmobile Intrigue

In-depth Vehicle Occupant Report

The University
of Michigan
Transportation
Research Institute

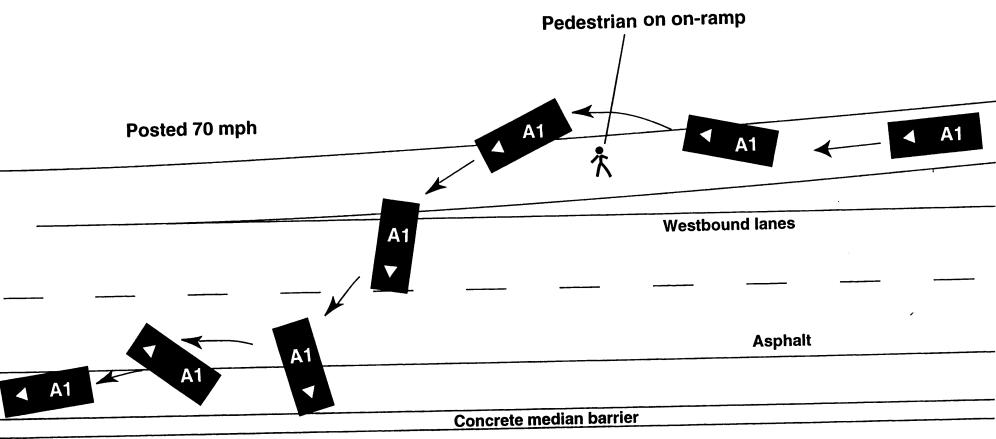
ACCIDENT SCHEMATIC

ACCIDENT DESCRIPTION: Cuse vehicle (A) was traveling in the westband on-ramp CASE VEHICLE (A): 1998 Oldsmobile	Intrique G
preparing to merge into traffic on a divided highway. The driver surved right to OTHER VEHICLE (B):	I
avoid a pedestrian on the on-ramp. Case vehicle (A) entered a counter clockwise THIRD VEHICLE (C): N/A	
you, crossed the westbound traffic lanes and struck a concrete barrier with its front end and came to rest	
on the paved shoulder on the south side of the road facing west.	(4)
	NORTH

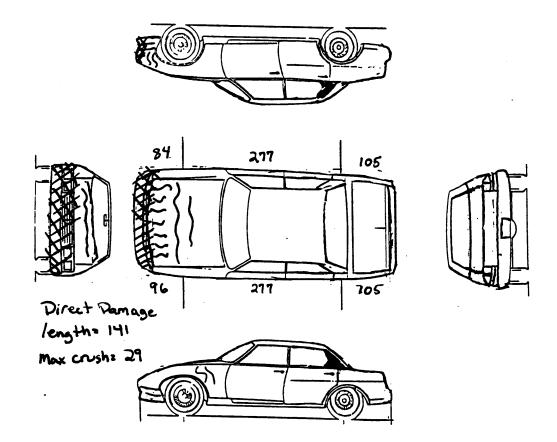
VEHICLE DAMAGE

(Slides 9, 10, 11, 12, 13, 14) Damage to case vehicle (A) was moderate. Direct-damage length was 141 cm and began at the right-front bumper corner. The maximum crush was 29 cm and occurred 25-cm inboard from the right front bumper corner. The front bumper and headlight assemblies were damaged. The hood was crushed and the latch released. The left and right hood hinges were damaged, but did not separate from the hood. The rear edge of the hood was elevated, but did not contact the windshield. The right and left fenders were damaged. There were stress cracks in the lower right corner of the windshield.

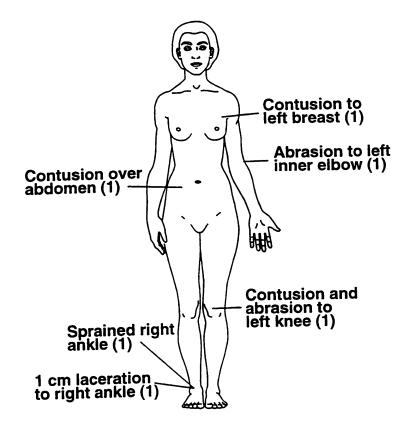
INDICATE LOCATION OF INJURIES.

The 38-year-old female driver was reportedly wearing the available 3-point belt. On impact, she moved forward into the belt restraint and the deploying airbag. She sustained a contusion to her left breast from contact by the shoulder belt. She sustained an abrasion to her inner left elbow, probably from contact by the deploying airbag. She sustained a contusion over her abdomen from loading by the lap belt. (Slide 30) She sustained an abrasion and a contusion to her left knee from contact with the underside of the steering column. She sustained a sprained right ankle, probably from contact with the floor pan, and a laceration to her ankle from contact with the bronze hook of her hiking boot.
